# WERE 900K DEUTSCHE TELEKOM ROUTERS COMPROMISED BY MIRAI? ([HTTPS://COMSECURIS.COM/BLOG/POSTS/WERE\\_900K\\_DEUTSCHE\\_TE](https://comsecuris.com/blog/posts/were_900k_deutsche_te)

Tue, Nov 29, 2016 Ralf

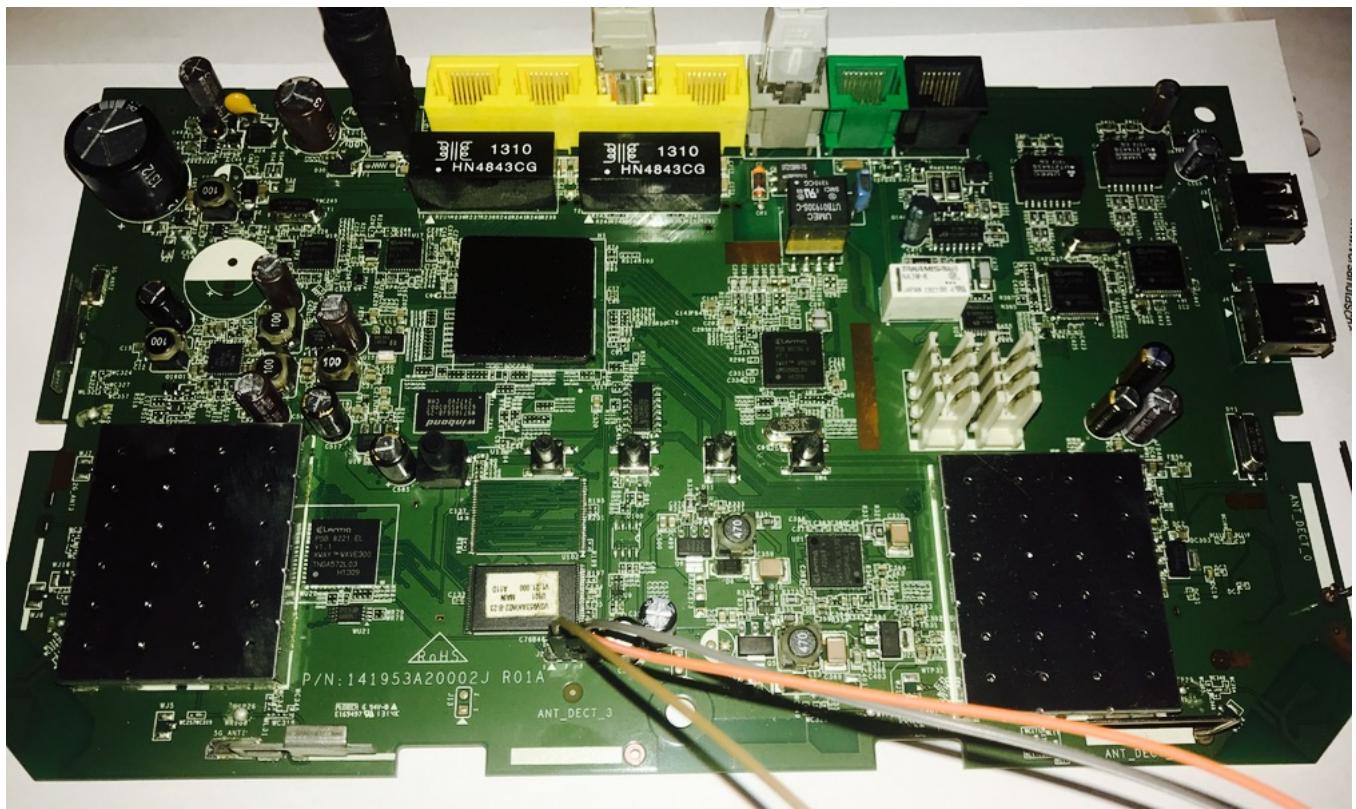
Meanwhile having obtained one of the vulnerable router models, a W921V running firmware version 1.39.0000 we attached it to a Deutsche Telekom DSL line for testing. In the same IP Phone Forum thread given above, we saw that a serial console is available, so we opened the router and connected a UART cable to the 4 PIN header next to the unpopulated ANT\_DECT\_J.
